Building Inspection Report

75 Barry Road, Dublin 21.

Document prepared by: A Surveyor ASCS MRICS

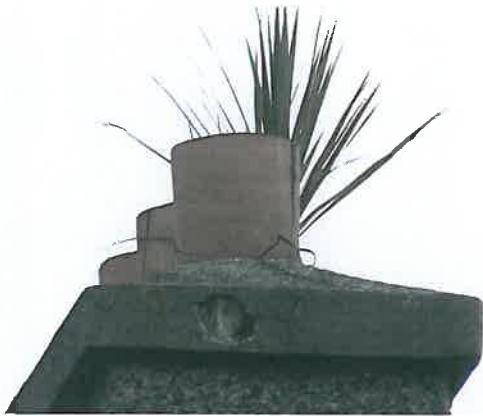
There is some damage noted to oversailing/top capping and some repairs are required.

The two rear chimney pots are cracked and probably loose and should be replaced. This damage appears to be as a result of vegetation growth noted to the top of the stack which should be removed. It is likely that relaunching of part of the chimney stack will be required, where the pots are held in place.

Cracked chimney pots and vegetation to top of stack. Cracked/damaged render to top section.

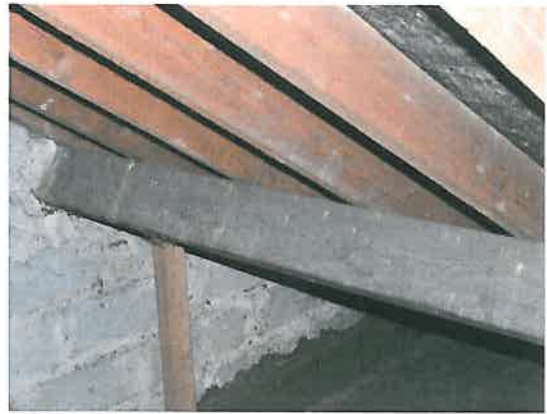
Woodworm evident to roof purlin.

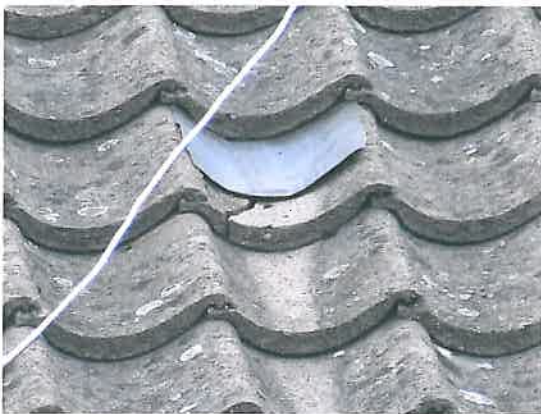
The roof tiles on the main roof are in fair condition but some repairs are needed. Several tiles on the rear roof slope are broken and should be replaced. One of the cracked/broken tiles has a felt patch or metal flashing repair over part of the crack although the lower part of the crack is visible/not protected. There is a risk of water penetration. There are at least two further other tiles that appear cracked. There is some general debris, moss, algae etc to the roof tiles which may conceal other cracked or damaged tiles. It may be difficult due to the age of the property to obtain matching replacement tiles.

Cracked roof tile to rear roof slope.

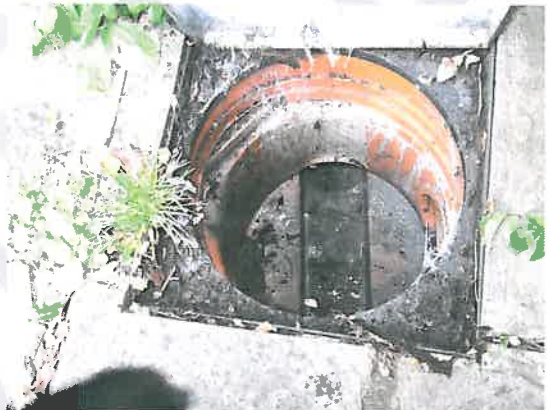
Where access could be obtained, the underground drains were partially blocked and need flushing through/cleaning. Should problems re-occur on a regular basis a camera survey of the drains may be needed.

Obstructions to below ground drainage system.
